TOWN OF FAIRFAX

SUBJECT: Adoption of a resolution declaring the existence of a local emergency at Meadow Way Bridge and authorizing the emergency procurement of materials and labor without competitive bidding.

Bridge Number : 27C0008
Facility Carried: MEADOW WAY
Location : IN FAIRFAX
City : FAIRFAX
Inspection Date : 07/16/2015

Bridge Inspection Report

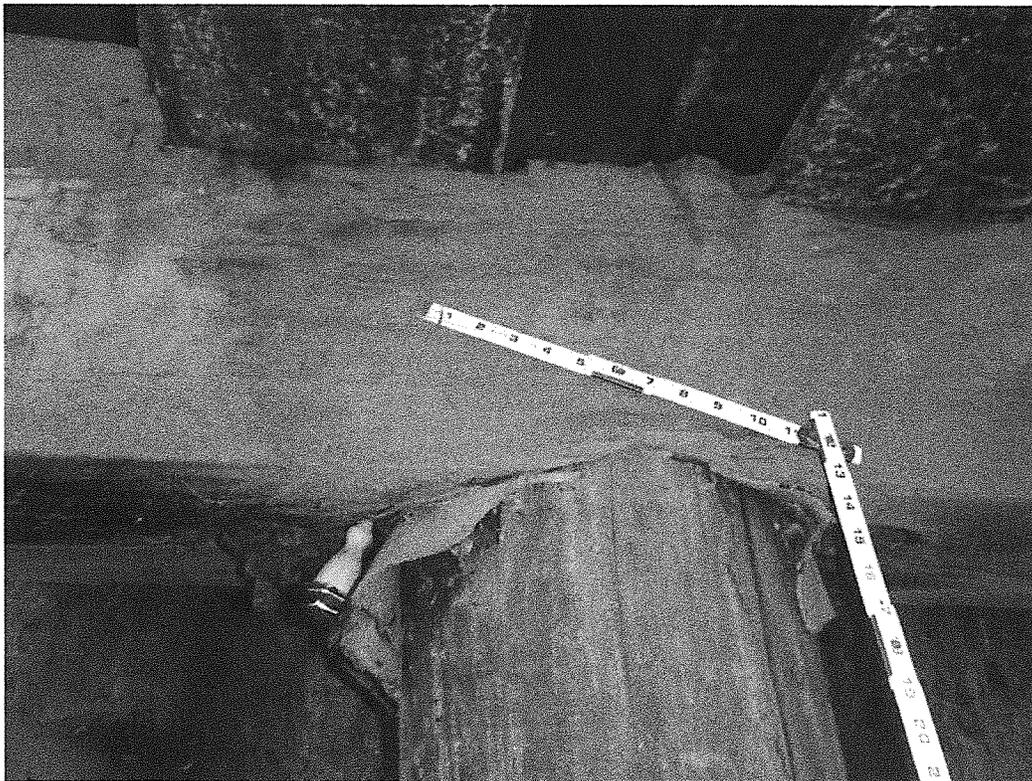
Photo No. 1

(215)								
There were no significant defects noted.								
228		Pile-Timber	2	1 ea.	1	0	0	0
(228)								
The pile element is included to indicate the presence of piles on this structure. The piles were not exposed for visual inspection. No indication of pile distress was noted in any substructure element.								
235		Pier Cap-Timber	2	27 m	5	18	0	4
1140		Decay/Section Loss (Timber)	2	4	0	0	0	4
1150		Check/Shake (Timber)	2	18	0	18	0	0
(235-1140)								
There is a vertical split in Bent cap 5, which extends from the left end to half length of the bent cap. Dry rot has occurred inside the bent cap along the vertical split. Approximately 50 percent of the timber cap has rotted. The bent cap portion at Column 1 has crushed about 1 inch. See attached photos.								
(235-1150)								
Bent cap 4 has a horizontal check full length. This condition was first noted in the 8/10/1999 report and has not significantly changed at this time. Based on a field comparison of the photo from the 9/2010 report, this condition has not changed.

Timber cap crushing at Pier 5 Column 1.

Replace timber bent cap at Pier 5.
Provided steel banding for Column 3 of
Pier 3.

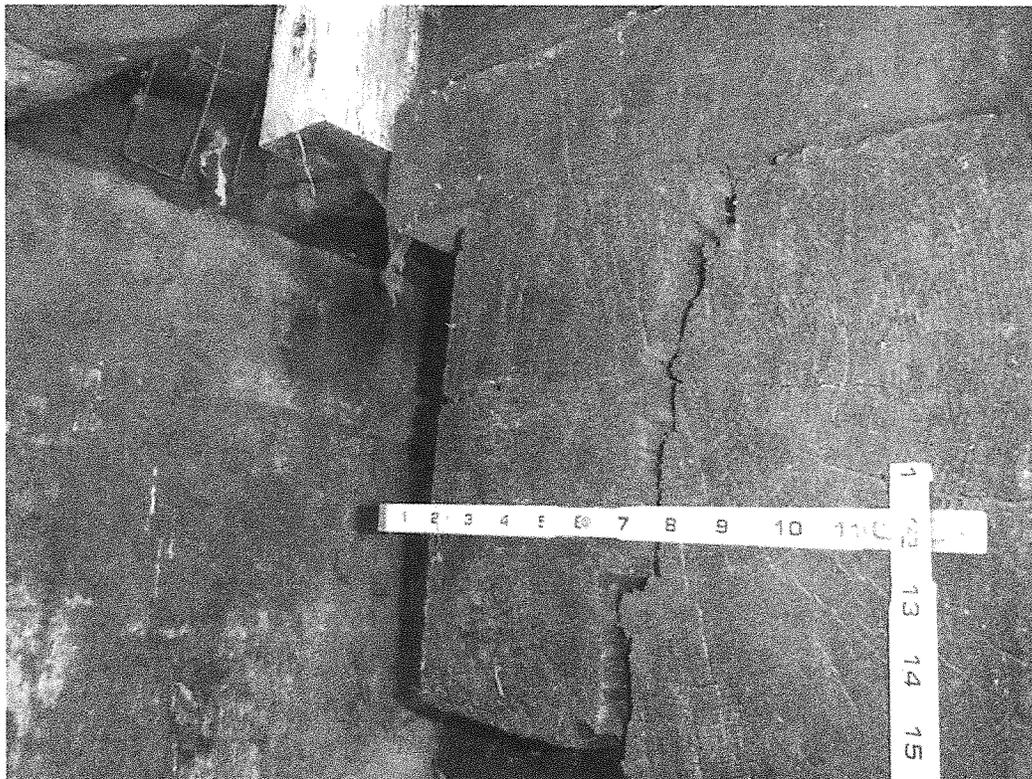
Photo No. 2

Timber cap split at Pier 5.

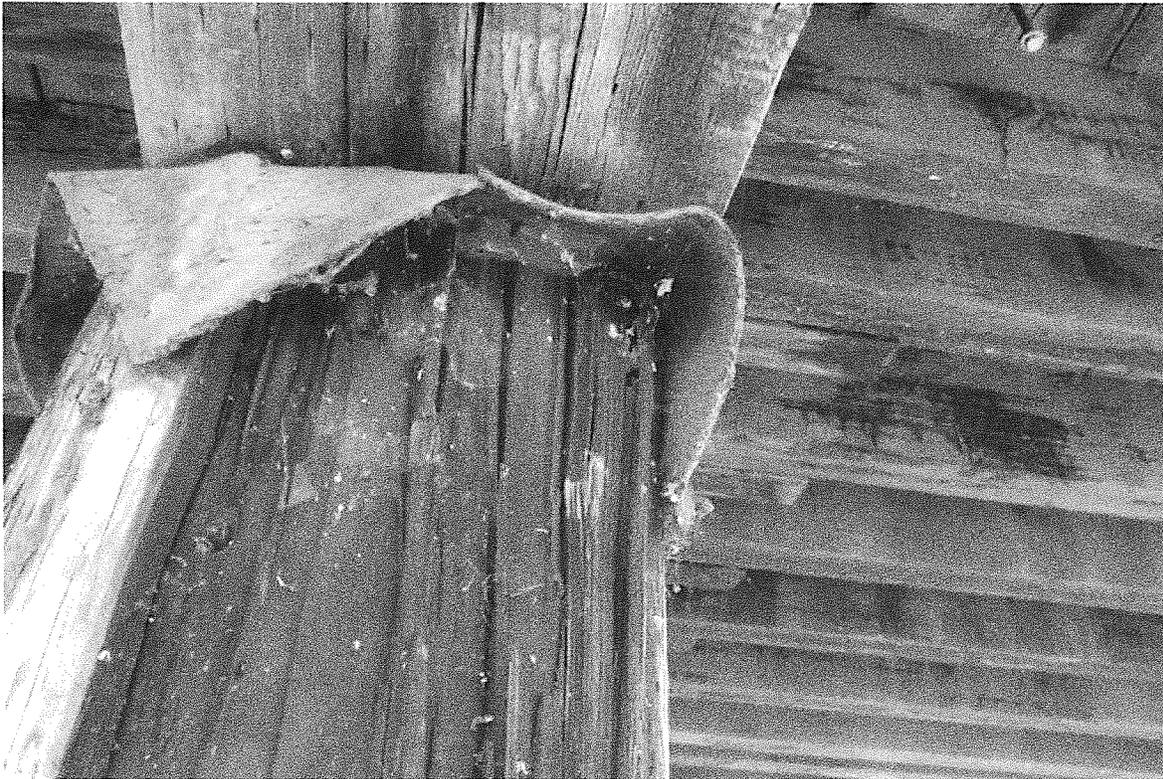
Photo No. 3

Elem No.	Defect /Prot	Element Description	Env	Total Qty	Units Qty in each Condition State			
					St. 1	St. 2	St. 3	St. 4
(206-1170)								
There are splits in the timber column at Column 3 of Pier 3. The splits are about 2 feet long by 2 inches deep around the perimeter. Currently, this condition does not affect the load capacity, but it is recommended to be repaired; install steel banding at the top of the column.								
215		Abutment-RC	2	9 m	9	0	0	0

Timber splits at Column 3 of Pier 3.

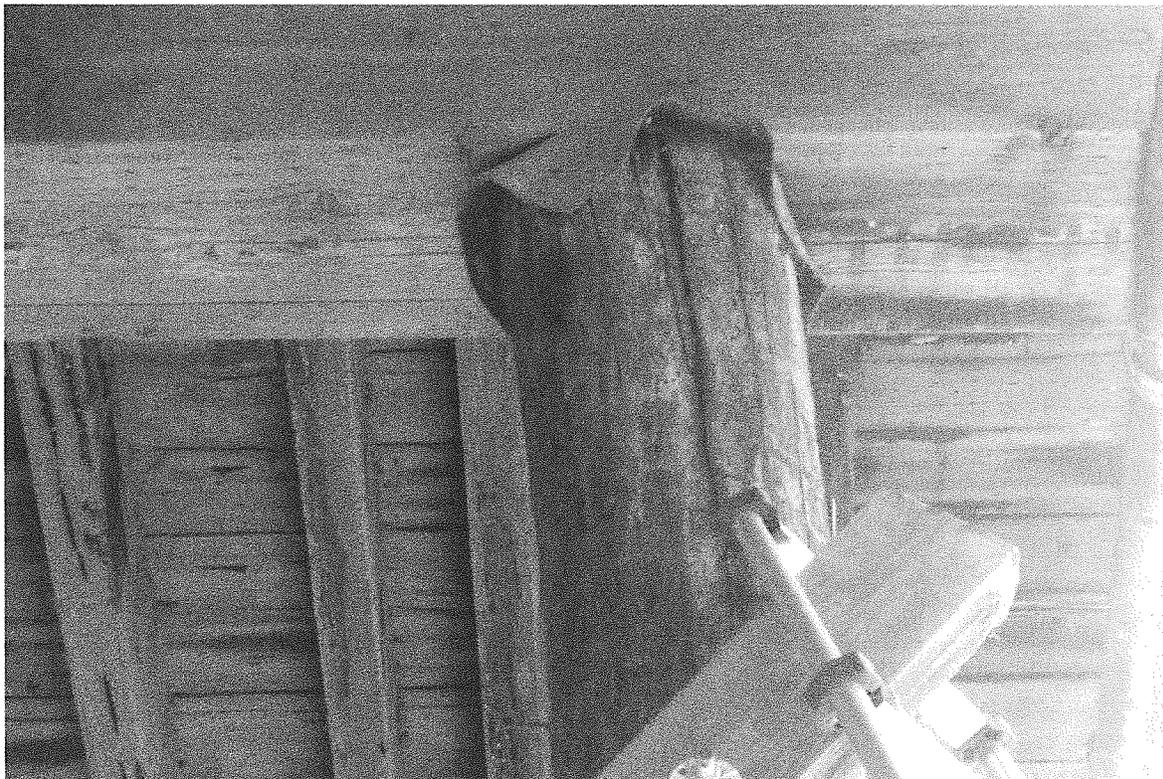
Photo No. 4

Timber splits at Column 3 of Pier 3.
