Address: 164 Willow, Fairfax  
Applicant: G Family Construction  
Application #: 14-0082

EXHIBIT # F

**164 Willow Avenue, Fairfax, CA  
Vegetation Fuels Management Plan  
&  
Tree Protection Plan**

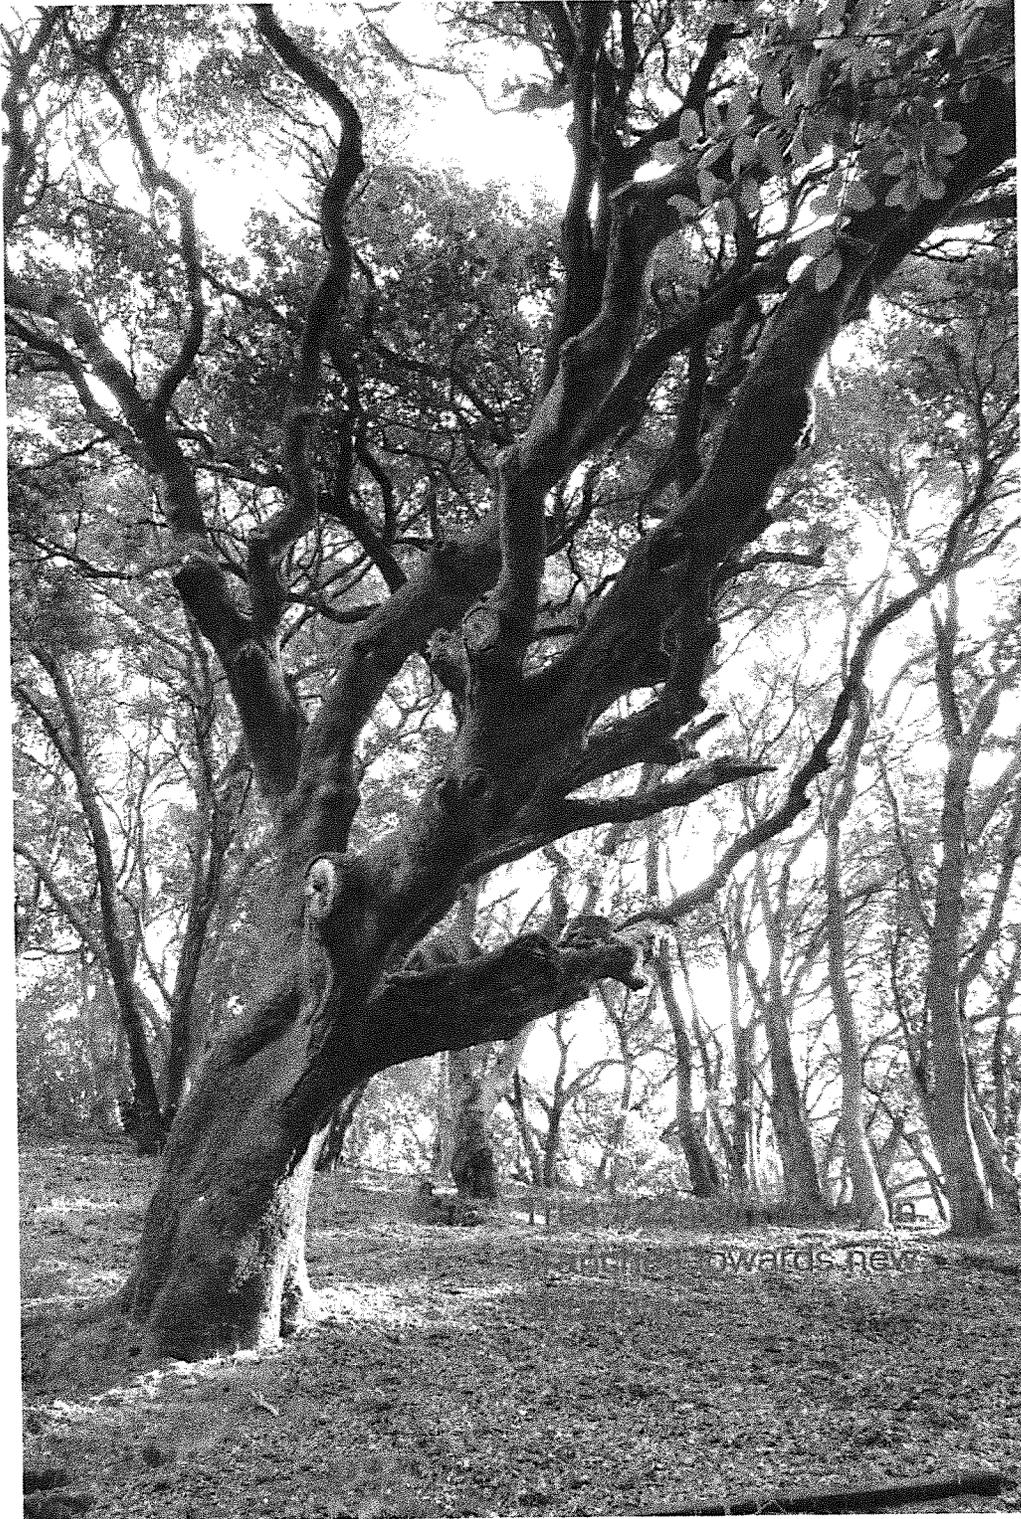
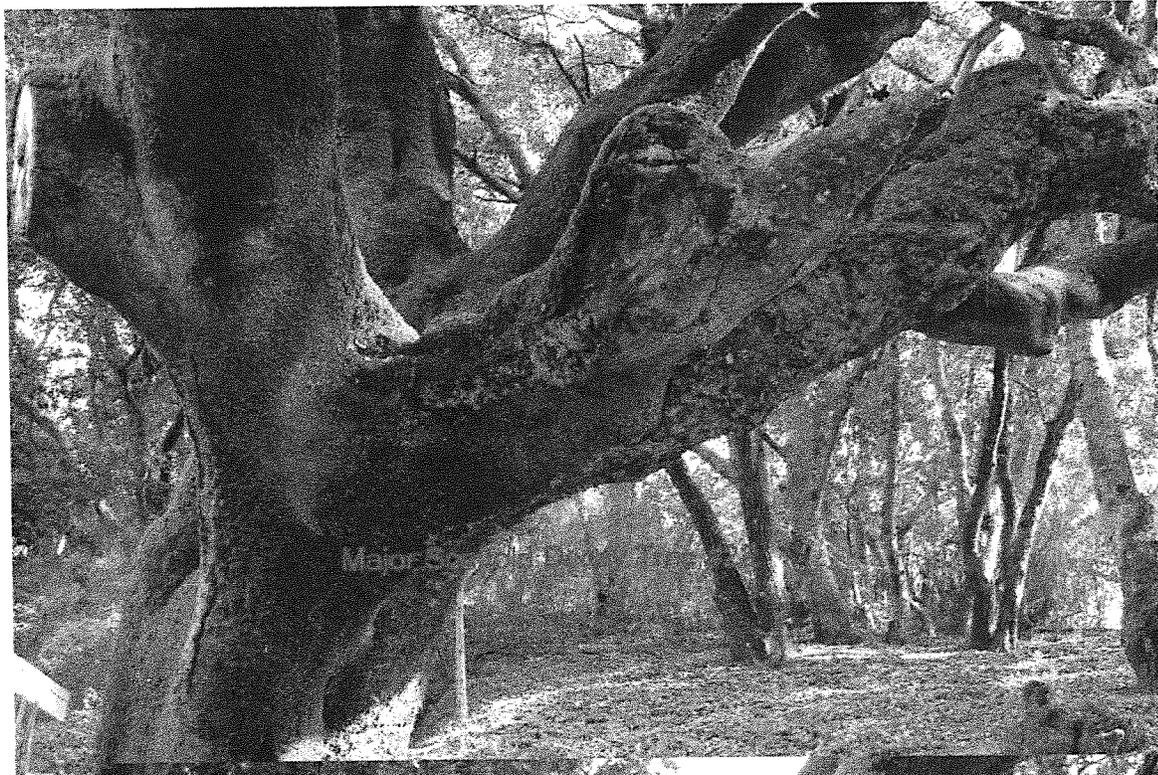
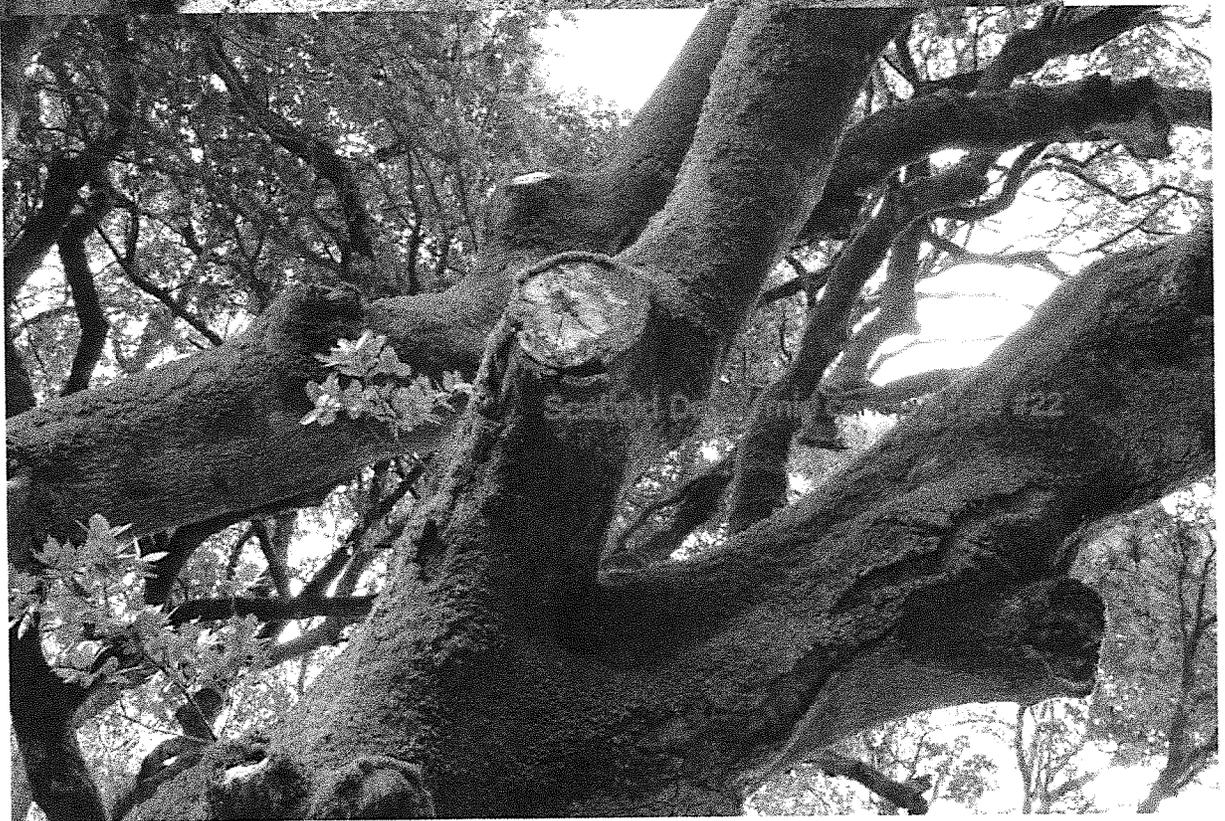
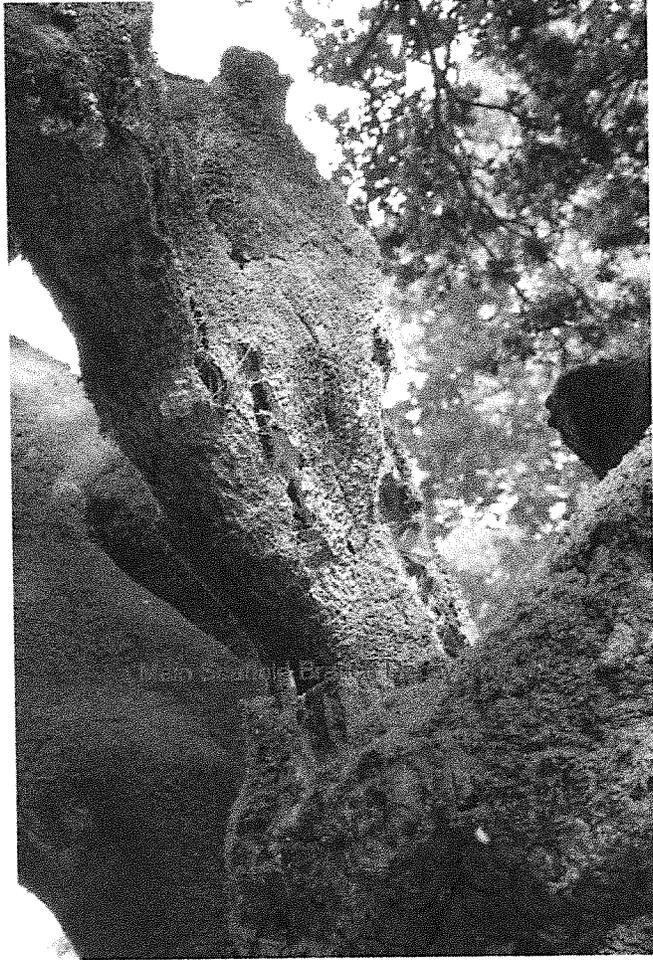
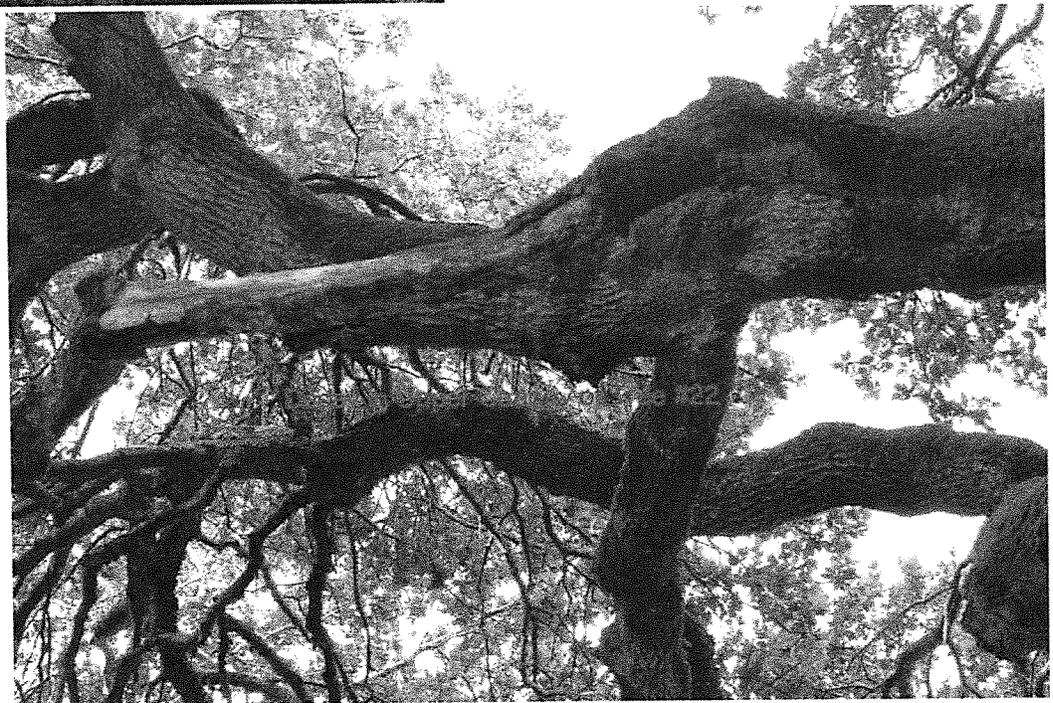
**Photographs of Tree #22**

Tree #	Species	Within Defensible Space	Condition	Recommendations/TPZ
22	Quercus agrifolia 38"	Yes	Good Vigor, significant decay in large scaffold branches, long laterals scaffold branches within target zone of new residence, root system within construction zone and soil disturbance will impact tree health (see attached photos)	Remove
23	Quercus agrifolia 6"	Yes	Good Vigor	Deadwood
24	Quercus agrifolia 12"	No	Good Vigor	Deadwood
25	Quercus agrifolia 11"	No	Poor Vigor	Remove to increase canopy spread for #26
26	Quercus agrifolia 9"	No	Good Vigor	Deadwood
27	Quercus agrifolia 12"	No	Poor Vigor	Remove to increase canopy spread for #26
28	Quercus agrifolia 48"	No	Good Vigor	Deadwood, Remove 1 lower scaffold branch on the east side to improve crown separation
29	Arbutus menziesii 8"	No	Poor Vigor	Remove
30	Arbutus menziesii 7"	No	Good Vigor, 45 degree lean	Remove to improve crown separation for Tree #28
